## Water entry function of a hardboard siding-clad wood stud wall

**NRCC-49449**

Sahal, N.; Lacasse, M.A.

A version of this document is published in / Une version de ce document se trouve dans:  
Building and Environment, v. 40, no. 11, Nov. 2005, pp. 1479-1491  
Doi:[10.1016/j.buildenv.2004.11.019](https://doi.org/10.1016/j.buildenv.2004.11.019)

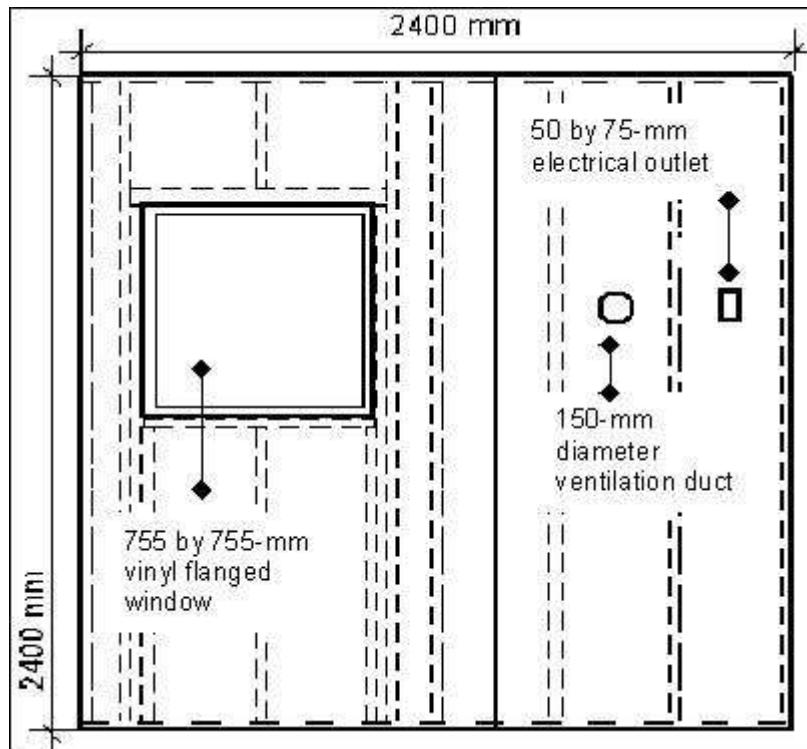
Fig 1. Location of through wall penetrations in test specimen (external elevation) [15]

Three basic components were incorporated in the assembly, a vinyl flanged window, an electrical outlet and a ventilation duct, which is a component of ventilation system that exhausts air from kitchens, bathrooms, and supplies outside air to habitable rooms. The location of each three components is shown in Fig. 1. Each of these components penetrated the siding (1<sup>st</sup> line of defence), sheathing membrane (2<sup>nd</sup> line of defence) as well as the sheathing board, and hence was considered as a through wall penetration.

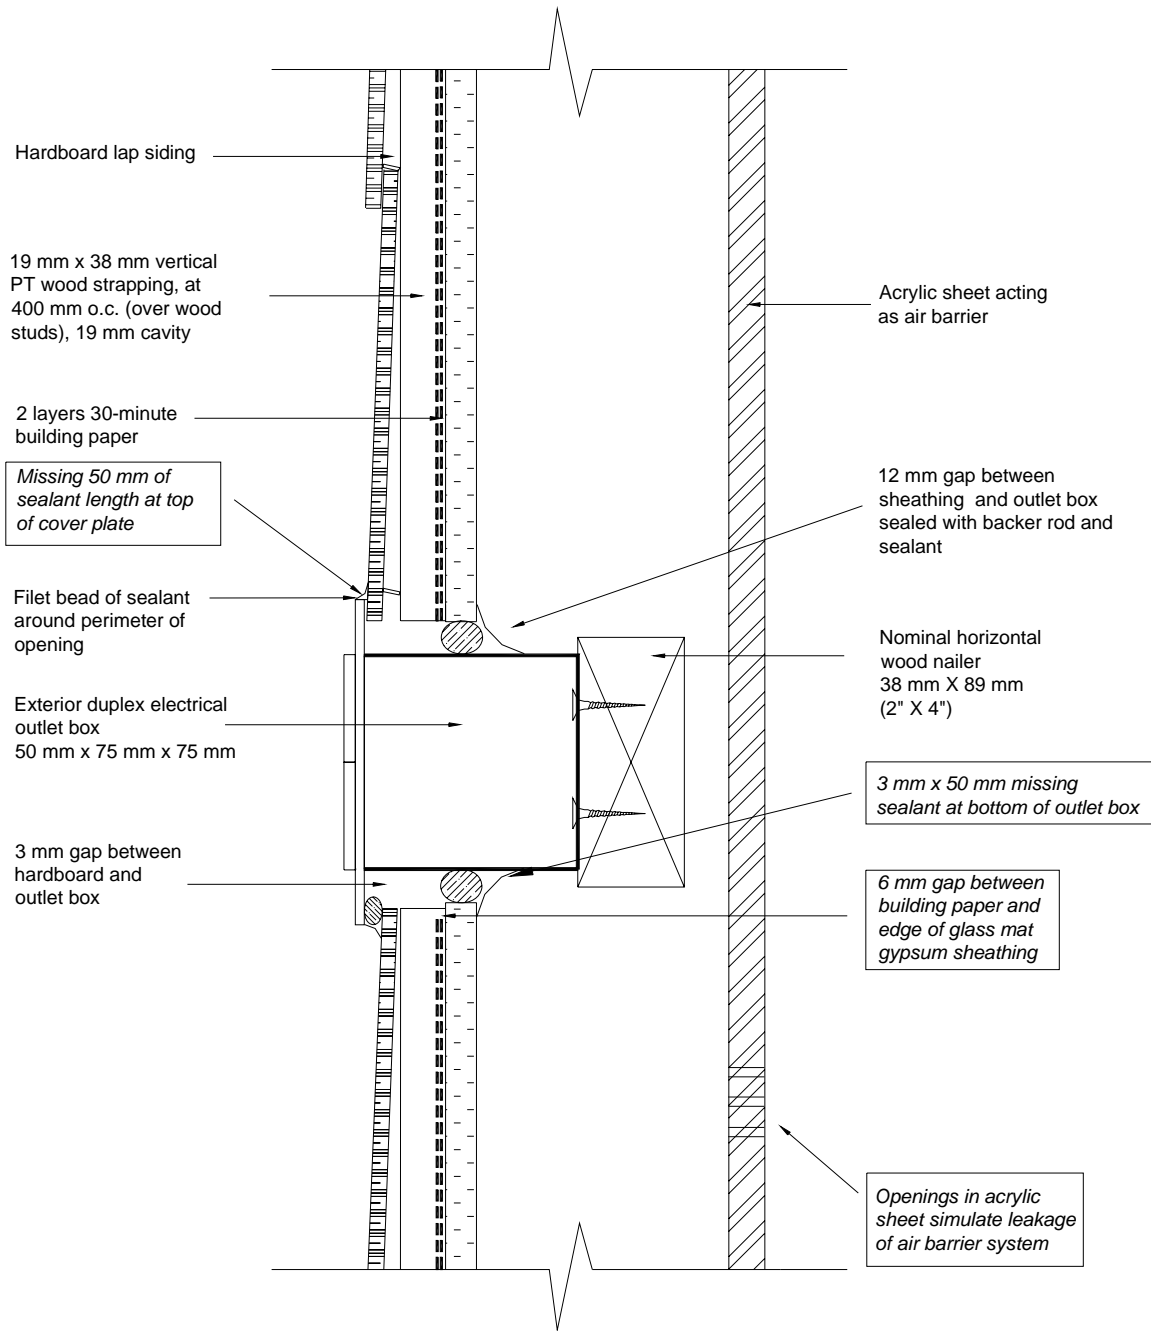
Fig 2. Wall-electrical outlet interface – vertical section [17]

An acrylic board situated on the outer surface of the wood studs served as the air barrier system. As illustrated in Figs 2 to 4, a series of three 6-mm diameter holes were introduced in the acrylic board about the centre of each of the stud space. Opening or closing the appropriate number of holes in the air barrier system could regulate the nominal rate of air leakage through the assembly.

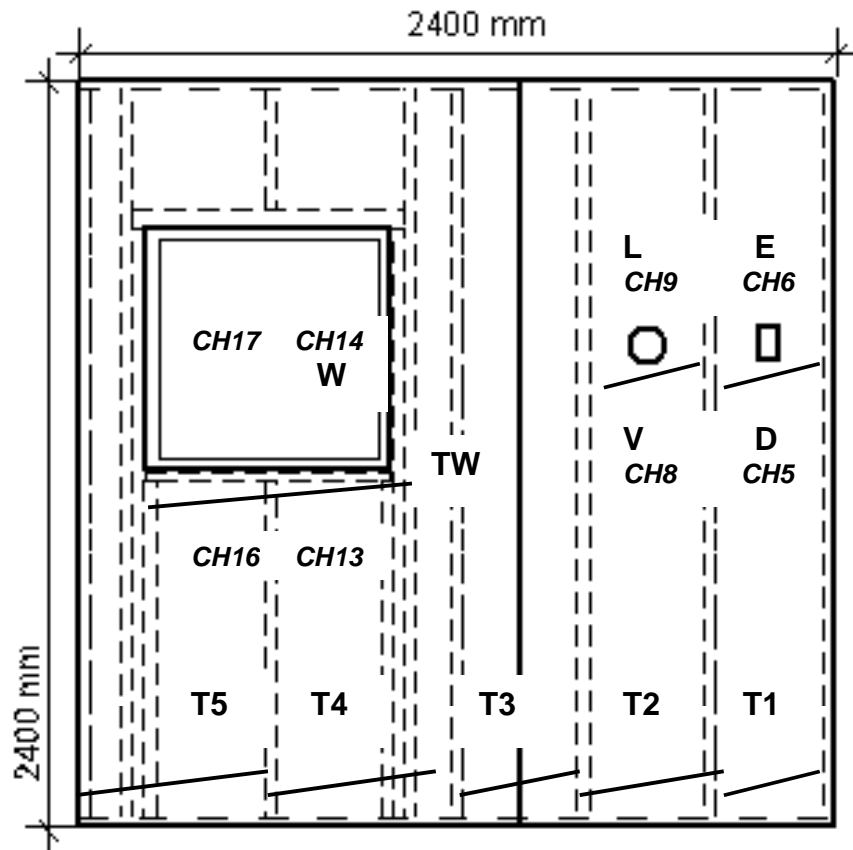
Fig 5. Location of water collection troughs and pressure taps [15]

Locations of each trough are illustrated in Fig 5. Troughs D, V, and TW were located in the 19-mm cavity, beneath the respective penetrations, i.e. electrical outlet (D), vent duct (V) and window (TW). Deflectors were placed above each component in the 19-mm cavity in order to prevent any unintentional water entry from above portion of the wall cavity to dilute the entry results in the troughs. As well, troughs T1 to T5 were located at the base of the wall in the cavity behind the cladding. Troughs T1 to T5 collected water that might penetrate the cladding and be deposited in the cavity. These troughs were limited nominally to the breath of a stud space. Additionally, three troughs were situated in the stud cavity beneath the electrical outlet (E), vent duct (L) and window (W).

Pressure taps were located in six parts of the wall assembly as shown in Fig 5. In each part, pressure taps were located in the 19-mm cavity between the siding and the sheathing board, and in the stud cavity. Certain pressure taps were specifically located in proximity to the deficiencies to obtain the pressure differences that may affect the likelihood of water entry past the cladding and the sheathing board.

When the ABSL of the specimen was either 0.3, 0.4 or 0.6  $\text{L/s}\cdot\text{m}^2$ , the pressure drop at each pressure tap locations, which are given in Fig. 5, was measured for each given static pressure differences. Pressure drop is simply the difference between the static pressure difference across the specimen and the actual pressure at that specific tap location, namely the driving pressure. The driving pressure is the amount of pressure to drive water through an opening. Hence, the driving pressure ratio is the ratio of driving pressure across the cavity in relation to static pressure difference across the specimen. The higher this value, the greater driving pressure across the opening.

Pressure taps of interest across the width of the wall at the electrical outlet were CH5 and CH6, which were located at proximity to water collection troughs D and E, as given in Fig. 5. When the assembly provided an ABSL of  $0.3 \text{ L/s}\cdot\text{m}^2$ , the driving pressure ratio within the drainage cavity and stud cavity ranged from 0.0 to 0.1 for the given pressure range. Similar results were obtained when the ABSL was 0.4 and  $0.6 \text{ L/s}\cdot\text{m}^2$ . The results indicated that the acrylic sheet provided the greatest resistance to air pressure throughout the test.

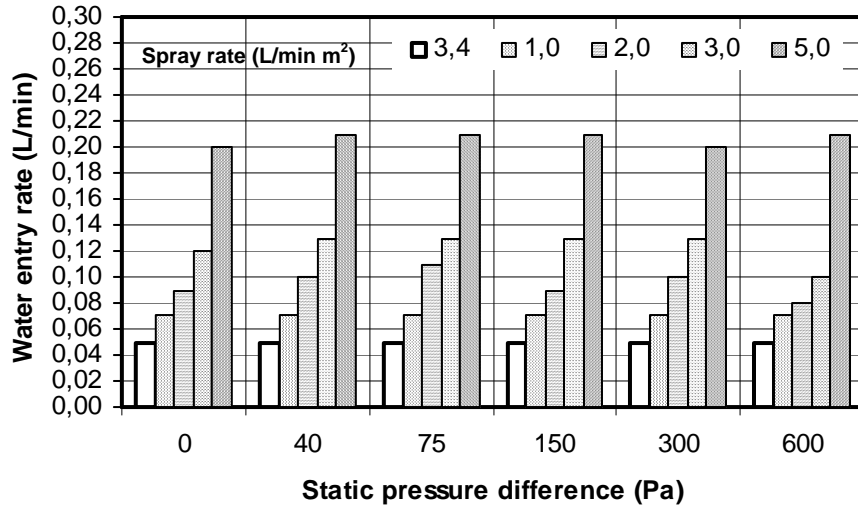
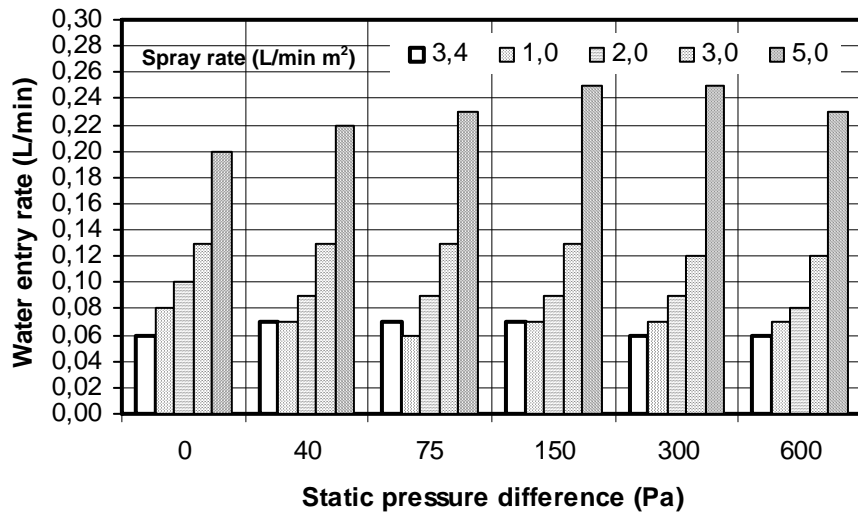
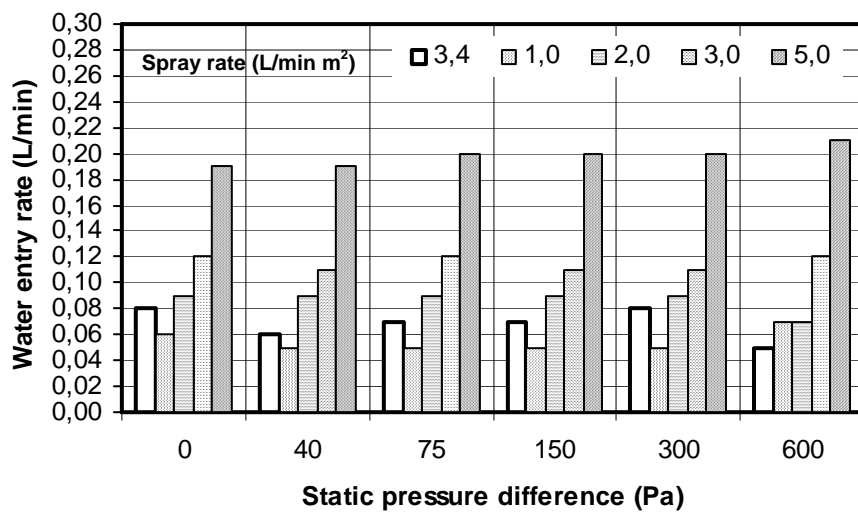
Fig. 6. Water entry rates through the deficiency above the electrical outlet that was collected at trough D, (a) ABSL 0.3 L/s m<sup>2</sup>, (b) ABSL 0.4 L/s m<sup>2</sup>, (c) ABSL 0.6 L/s m<sup>2</sup>

Water entry rates in trough D at a given pressure level as a function of spray rates for each degree of air barrier system leakage is given in Fig 6a, b and c. A comparison of the range of values of entry rates in relation to changes in spray rates at a given pressure step to the range of values of entry rates in relation to changes in pressure levels at a given spray rate suggest that water entry rates are primarily dependent on the spray rate and not to the pressure difference across the assembly.

Figs 6 to 8 demonstrate that cascading water rates on the cladding surface resulted in higher rates of water entry than compared to spraying water on the cladding surface. For example in Fig. 6a, the rate of water entry obtained was 0.05 L/min, when a rate of 3.4 L/min·m<sup>2</sup> was sprayed on the surface of the cladding and the pressure difference across the wall assembly was maintained at 40 Pa. At the same pressure step, water entry rates obtained were 0.07, 0.10, 0.13, and 0.21 L/min when the corresponding rates of 1.0, 2.0, 3.0 and 5 L/min·m<sup>2</sup> cascaded on the surface of the cladding.

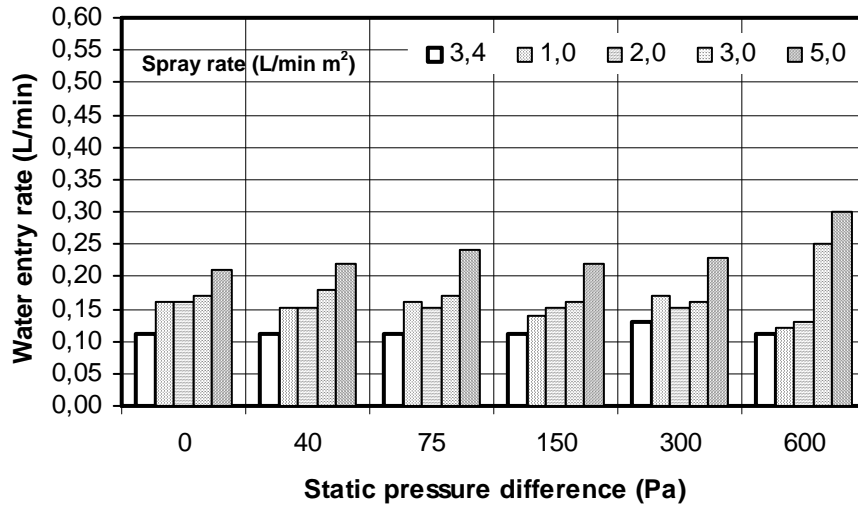
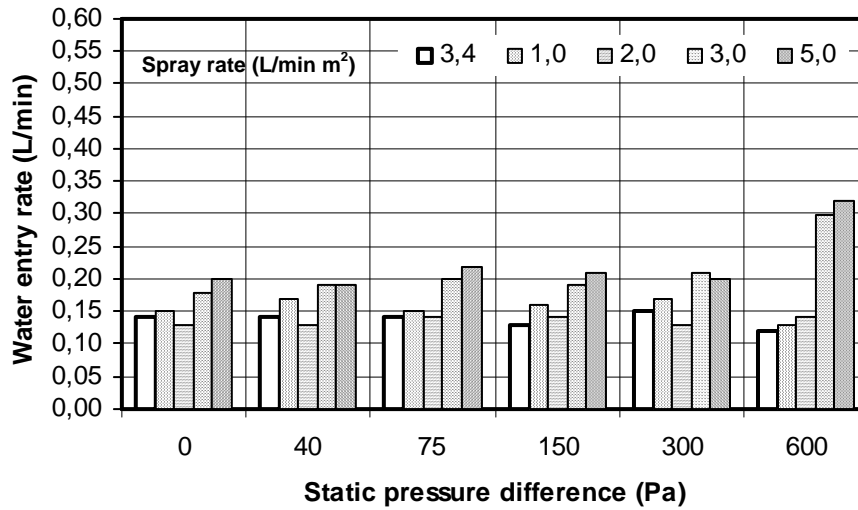
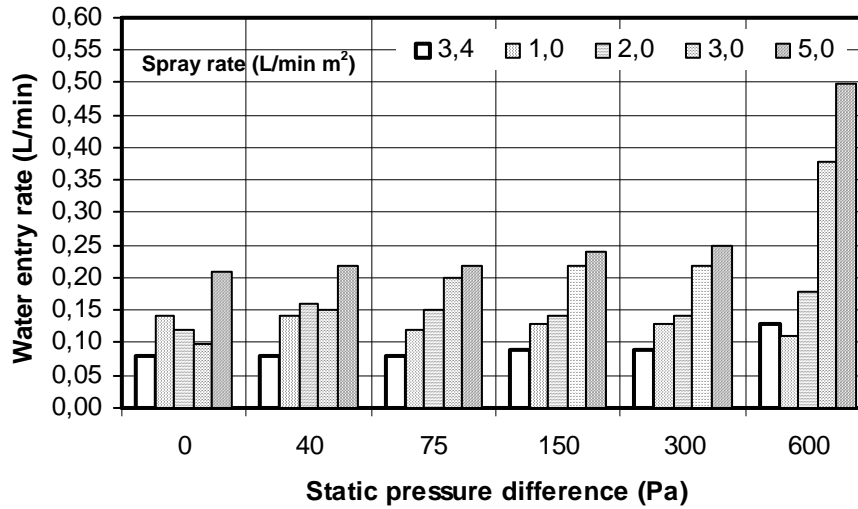
Fig. 7. Water entry rates through the deficiency above the vent duct that was collected at trough T2, (a) ABSL 0.3 L/s m<sup>2</sup>, (b) ABSL 0.4 L/s m<sup>2</sup>, (c) ABSL 0.6 L/s m<sup>2</sup>

Water entry rates in trough T2 at a given pressure level as a function of spray rates when the assembly provided an ABSL of  $3.0 \text{ L/s}\cdot\text{m}^2$  is given in Fig 7a. Increases in spray rate tended to slightly increase the water entry rate in this trough at each given pressure level. However, the increase in the entry rates was evident for spray rates of  $3.0$  and  $5.0 \text{ L/min}\cdot\text{m}^2$  at pressure difference of  $600 \text{ Pa}$ .

Water entry rates for the ABSL of  $4.0$  and  $0,6 \text{ L/s}\cdot\text{m}^2$  are provided in Fig 7b and c, respectively. Similar results were obtained at each ABSL. The water entry rates at spray rates  $3.0$  and  $0.5 \text{ L/min}\cdot\text{m}^2$  and static pressure difference of  $600 \text{ Pa}$  increased at each increasing air barrier system leakage. Hence, the increase in the water entry rate was due to the increase in driving pressures across the cladding at static pressure difference of  $600 \text{ Pa}$ .

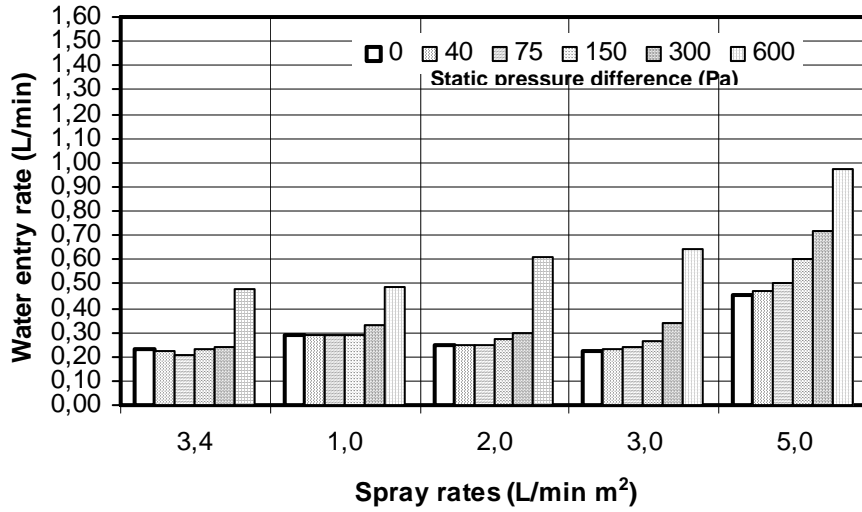
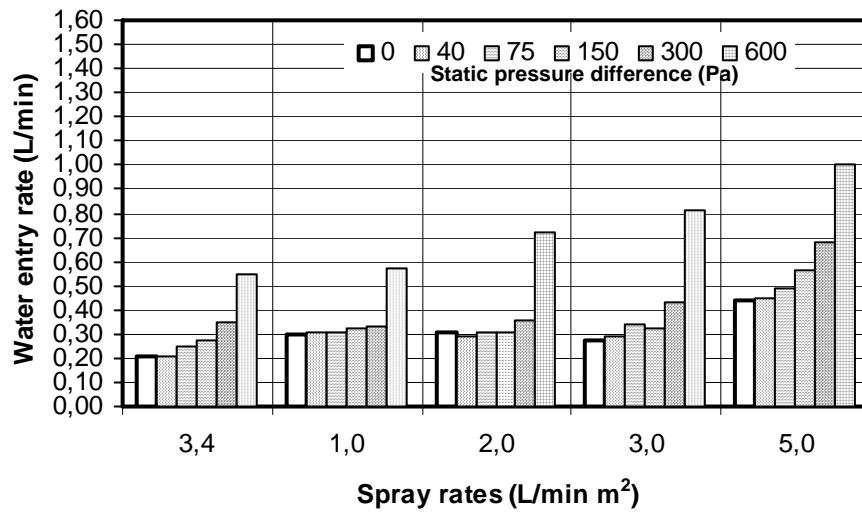
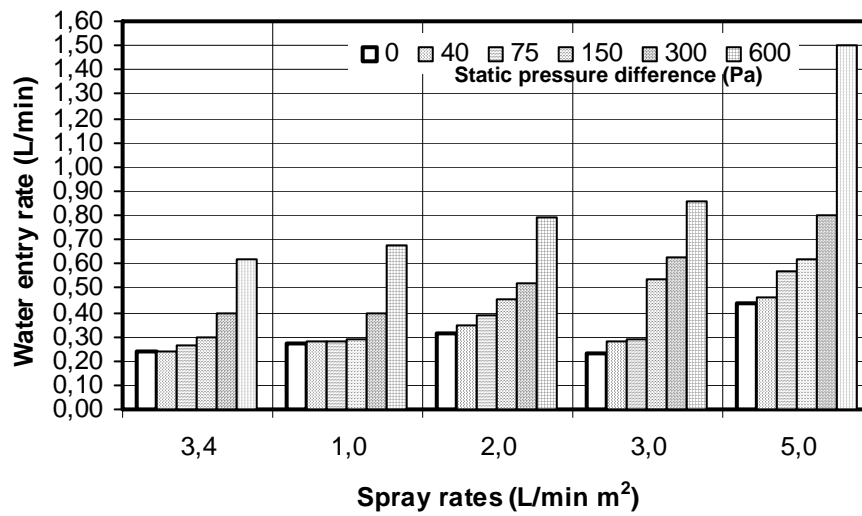
Fig. 8. Water entry rates through the deficiency at the window that was collected at troughs TW and T5, (a) ABSL 0.3 L/s m<sup>2</sup>, (b) ABSL 0.4 L/s m<sup>2</sup>, (c) ABSL 0.6 L/s m<sup>2</sup>

Fig. 8a illustrates the entry rates as a function of pressure differences across the specimen at given levels of spray rate when the assembly provided an ABSL of  $3.0 \text{ L/s}\cdot\text{m}^2$ . At the spray rates of 3.4, 1.0, 2.0 and  $3.0 \text{ L/min}\cdot\text{m}^2$ , the pressure applied on the cladding was increased at steps from 40 Pa to 300 Pa and the water entry rate tended to slightly increase at each pressure step. However, at the given spray rates of 3.4, 1.0, 2.0 and  $3.0 \text{ L/min}\cdot\text{m}^2$ , water entry rates increased significantly at the pressure difference of 600 Pa. Increases in rates of water entry in relation to corresponding increases in pressure difference across the assembly were evident at the spray rate of  $5.0 \text{ L/min}\cdot\text{m}^2$ .

Fig. 8b and c demonstrate that the same pattern had occurred when the system provided an ABSL of 4.0 and  $0.6 \text{ L/s}\cdot\text{m}^2$ , respectively. At the spray rate of  $5.0 \text{ L/min}\cdot\text{m}^2$ , the water entry rates ranged from 0.44 to 1.0 L/min with corresponding pressure differences of 0 Pa to 600 Pa at when the assembly provided an ABSL of  $0.4 \text{ L/s}\cdot\text{m}^2$ . The water entry rates ranged from 0.44 to 1.5 L/min with corresponding pressure differences of 0 Pa to 600 Pa, when the assembly provided an ABSL of  $0.6 \text{ L/s}\cdot\text{m}^2$ . Hence, increase in the air barrier system leakage resulted an increase in the water entry rates.

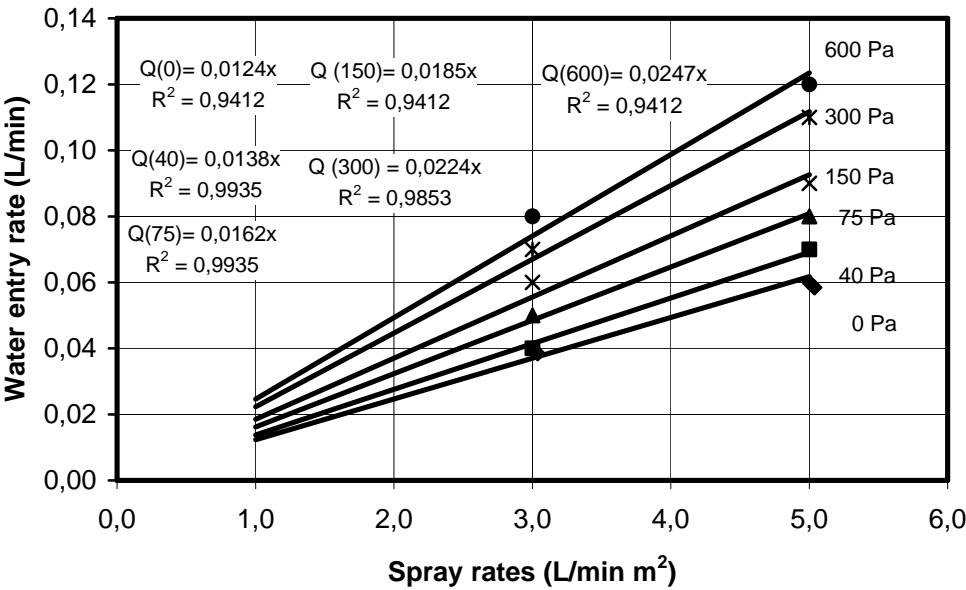
Fig. 9. Water entry rates as a function of spray rates

The linear function that relates the water entry rate Q (L/min) and spray rate (L/min·m<sup>2</sup>) for each static pressure difference (ΔP, Pa) is expressed as the following [15].

in which Q is the water entry rate (L/min), R<sub>p</sub> is the spray rate (L/min·m<sup>2</sup>) and m<sub>p</sub> is the water entry potential (L min<sup>-1</sup>/L min<sup>-1</sup> m<sup>-2</sup>) for which subscript p refers to the given static pressure difference across the assembly.

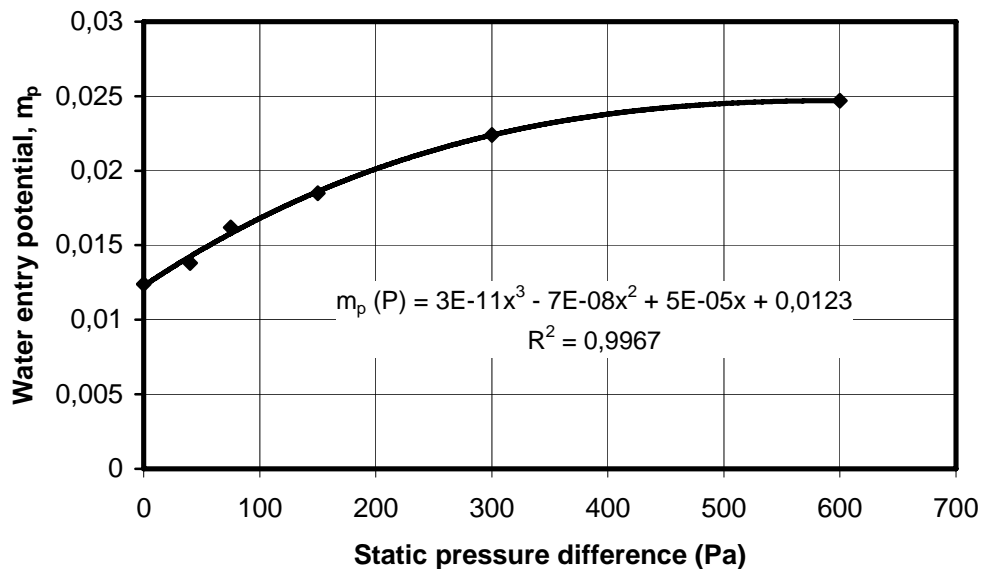
Fig. 10. Water entry potential as a function of static pressure difference

Thus, the water entry potential,  $m_p$ , can be plotted, as a function of static pressure difference, and as shown in Fig. 10, an empirical relation has been derived based on a third order quadratic equation. The water entry potential ( $m_p$ ) derived for the ventilation duct of the hardboard siding-clad wall, in relation to the static pressure difference is the following.

Values of water entry potential range from 0.0124 to 0.0247 L min<sup>-1</sup>/L min<sup>-1</sup> m<sup>-2</sup> in relation to corresponding static pressure differences of 0 to 600 Pa. The reliability of the function is  $R^2 = 0.9967$ , indicating a strong fit of data to the curve.
