Pipelines 2012, pp. 288-297, 2012-08-22

Condition Evaluation of Asbestos Cement Water Mains

Rudaba Chowdhury*, Yafei Hu, and Dunling Wang

National Research Council Centre for Sustainable Infrastructure Research

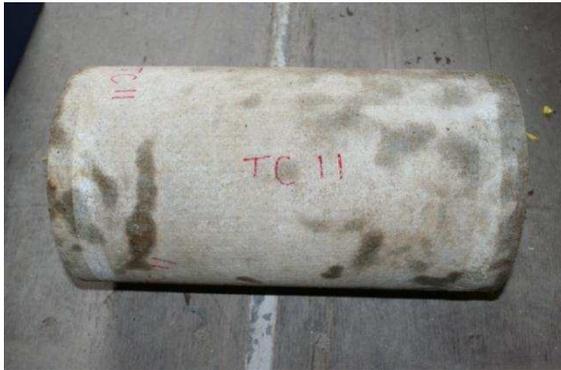
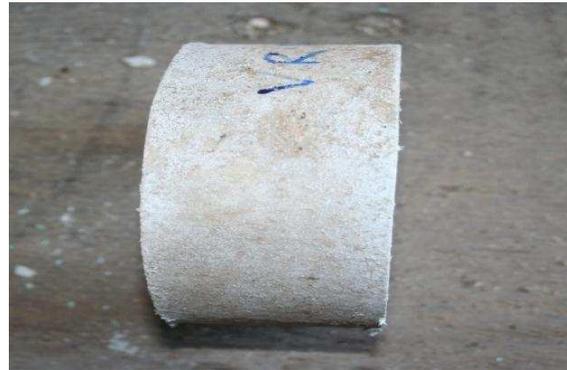
Figure 1: Cut AC pipe samples

Wherever possible, a 300 mm long sub-sample was first cut for crush testing (Figure 1a) and the remaining portion of the pipe (Figure 1b) was used for chemical tests and elemental analysis. The sub-samples for crush tests were removed from the barrel portion of the pipe, avoiding tapered joint ends and any obvious damage. The detailed test procedures are summarized by Hu et al. (2011).

(a) 300 mm sub-sample for crush test

(b) 100 mm long section for chemical analysis

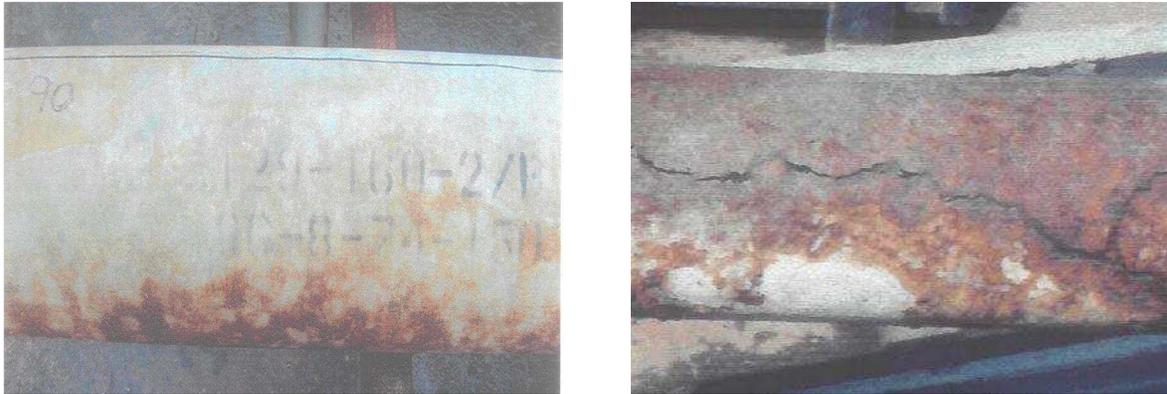
Figure 2: Visual examination of degraded pipes

The pipe samples from utilities A and B were relatively intact and did not show significant exterior deterioration except for some pipes that had rust and/or stain deposits (Figure 2a). Some of the samples from utility C showed severe distress, for instance, the removal of the smooth cementitious layer and cracks on the outside surfaces (Figure 2b).

(a) Slightly deteriorated pipe

(b) Severely deteriorated pipe

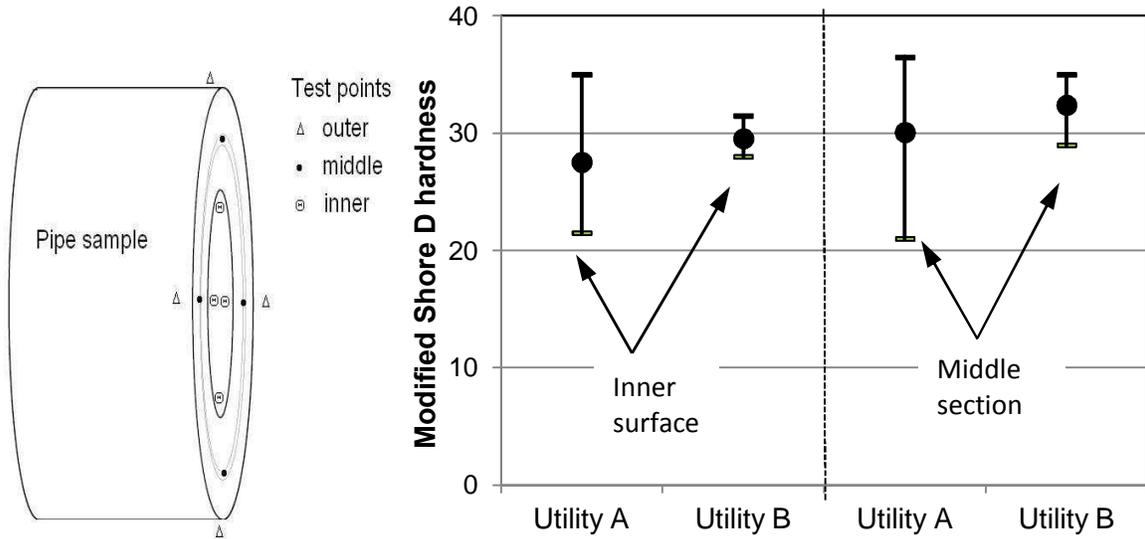
Figure 3: Barcol hardness tests of AC pipe samples

Figure 3b shows the hardness test results for inner and middle sections (as shown in Figure 3a) of AC pipe samples as measured using the modified Shore D durometer. The hardness in the middle section was higher than that on the inner surface. This was expected as almost all pipes had some essentially undegraded areas in the middle section.

(a) Test points

(b) Hardness test results

The hardness values measured on the outer surface (not shown) were generally higher than those in the middle section. This may be related to the waffle pattern on the outside surface of AC pipes, which made it difficult for the durometer to be positioned in close contact with the outside surface.

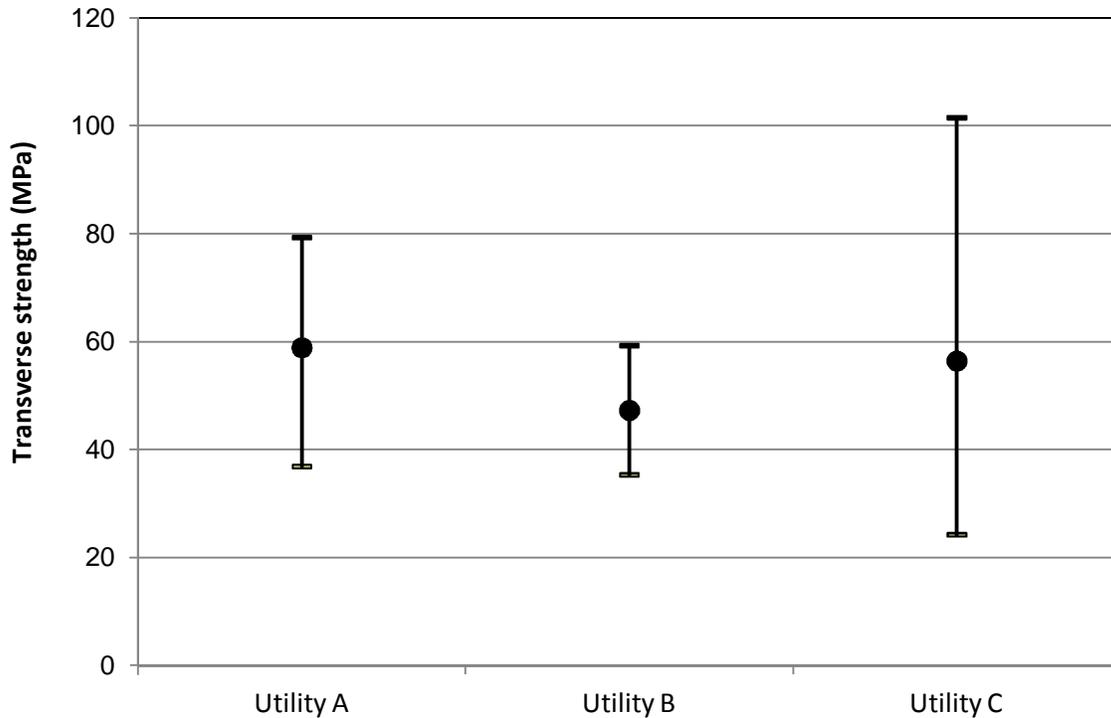
Figure 4: Transverse crush strength of AC samples

The load value at the point of failure was recorded for each crush test. The corresponding transverse failure strength was calculated based on the value of the failure load and the measured dimensions of the sample. Figure 4 plots the crush strength data for samples from the three utilities. In Figure 4 and following figures, a dot in a figure represents the average value, while two bars represent the maximum and minimum values measured.

Transverse strength is a material property and a change in transverse strength reflects the change in the structure of AC pipe material due to deterioration. Figure 4 shows that utility C had the most variation in pipe strength, while utility B had the least variation, with utility A in between. The transverse strength for new Class 150 AC pipes is about 45 MPa (AWWA, 2003). This figure indicates that the deterioration resulted in about 18% of pipes samples with transverse strength below specifications.

The effect of the different aggressiveness of the conveyed water on the transverse strength of AC pipes cannot be observed in Figure 4 because the pipe samples have different ages. Figure 6 re-plots the transverse strength with sample age included. Again, the utility with the most aggressive water (utility C) had the greatest decrease rate in transverse strength and the utility with the least aggressive water (utility B) had the smallest reduction in transverse strength (MPa/year).

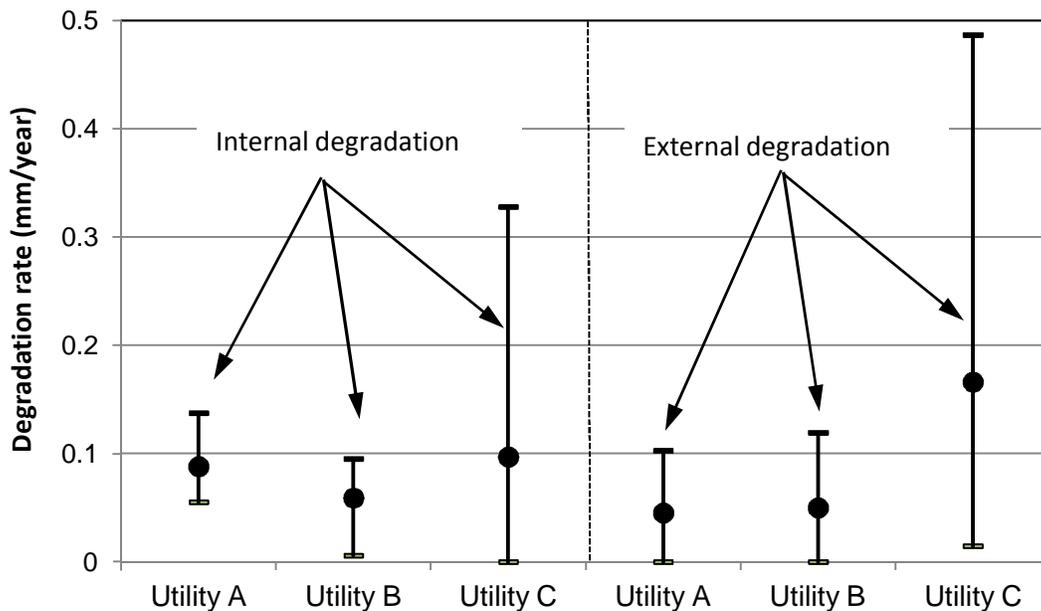
Figure 5: Internal and external degradation rates of pipe samples

Figure 5 shows the measured internal and external degradation rates from the phenolphthalein tests. Degradation rates were calculated by dividing the measured degradation depth of a pipe sample by the service years. Both the internal and external degradation rates varied significantly from sample to sample and from utility to utility. The samples from utility A degraded more rapidly on the inside than the outside, while the opposite occurred for utility C. Utility B had similar degradation rates on both internal and external surfaces. In general, variation in degradation rates was much greater on the outside than on the inside. This may be because the soils surrounding AC pipes may vary significantly for a given utility, but all AC pipes in a utility likely experience the same (possibly time varying) conveyed water quality.

The dry summer and low annual precipitation experienced by utilities A and B lead to arid soil conditions and low water tables. As lime leaching and sulphate attack all require an environment with soil pore water present for ions to move through the soil, an arid environment with low soil moisture content will minimize leaching and sulphate attack. When the leached products cannot be dispersed into the surrounding soils, they will become highly concentrated and slow down further leaching. That may explain the relatively low degradation rate of AC pipes for utilities A and B (Figure 5). On the contrary, utility C is located in a low-lying alluvial area near the coast and has a high water table, conditions that are conducive to the degradation of AC pipes buried in the soil. Also, the alluvial deposition can produce a soil environment with high sulphate content, which may contribute to the high degradation rate of the AC pipes operated by utility C (Figure 5).

The effect of the different aggressiveness of the conveyed water on the deterioration of AC pipes in the three utilities can be observed in Figure 5. Utility C, with very aggressive water, had the highest internal degradation rate and the highest average internal degradation rate. Utility B, which had the least aggressive water, had the lowest average internal degradation rate. Utility A experienced an average internal degradation rate in between, which corresponded to conveyed water with an aggressiveness index in between those of utilities B and C.
